# **CASE RECORD**

**DR.FATIMA HASAN AHAMED MARIKE**

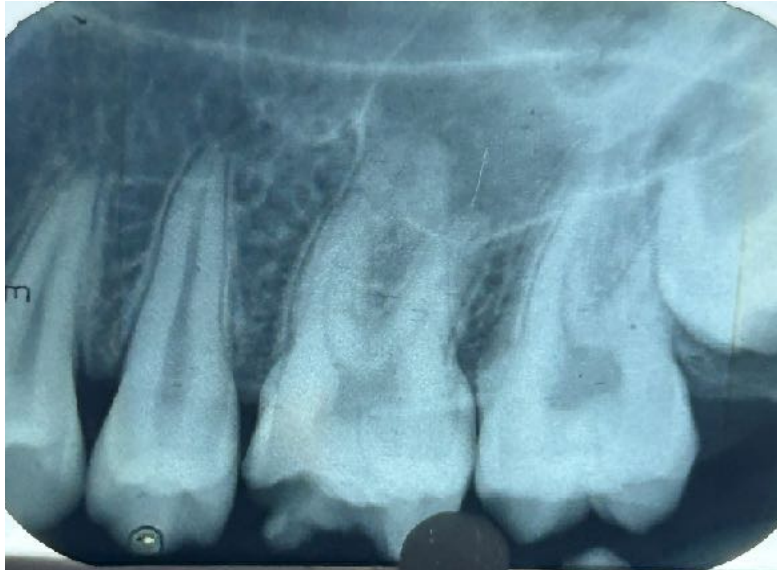
Pre-operative radiograph

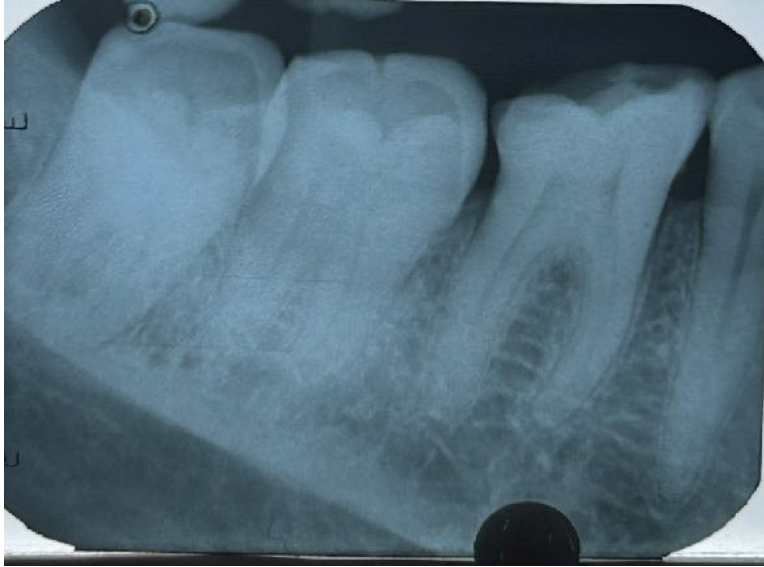
Pre-operative radiograph

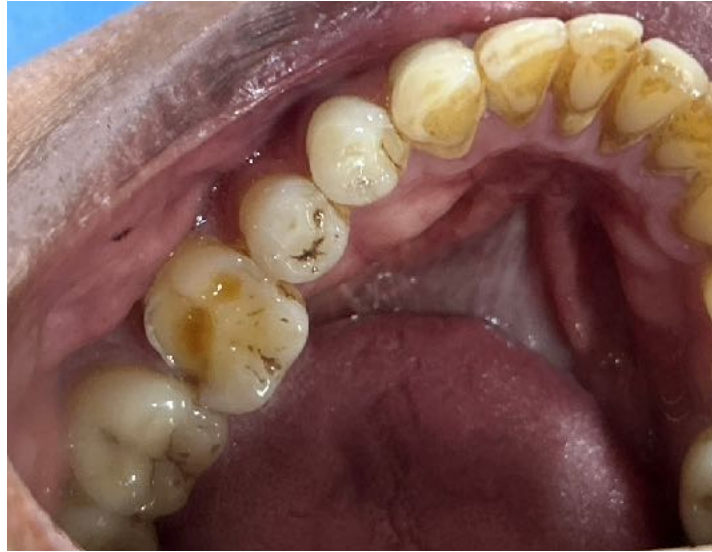
Intra-oral photograph showing fractured buccal cusp

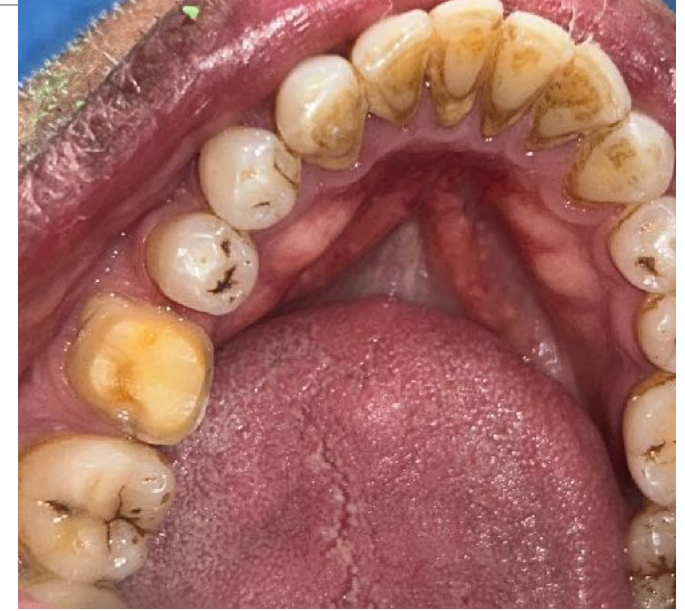
Onlay preparation done wrt 46

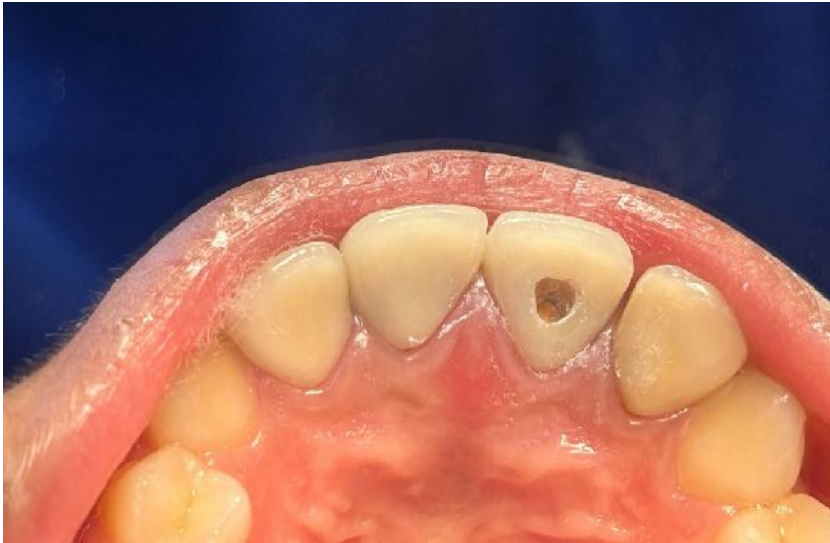
Obturation done wrt 11 and sealer has spread into lesion

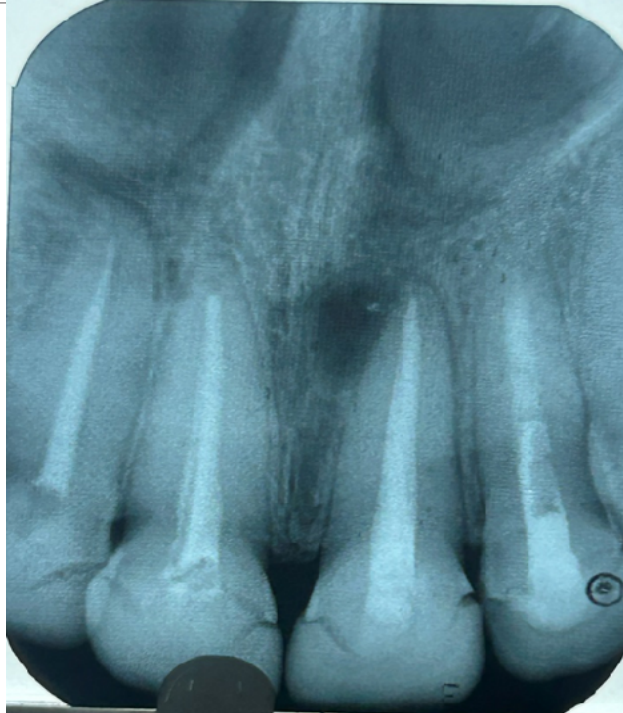
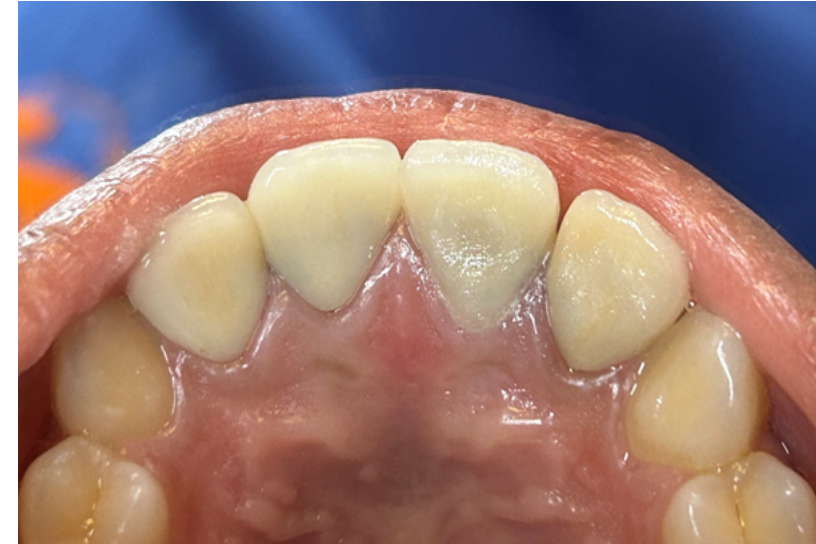
Post endo-composite restoration done

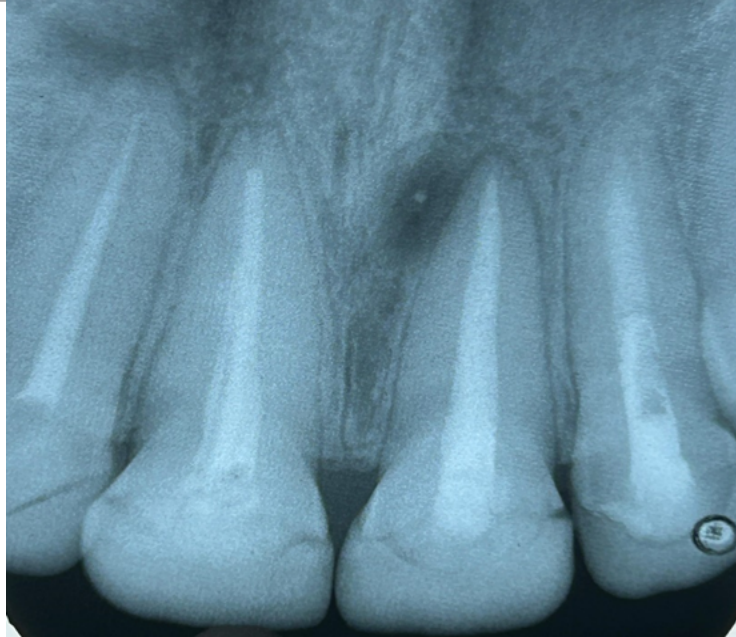
After 1 month recall  
Lesion has reduced its size,  
Formation of bone rarefaction can be noticed
